## WHY HAS MY TURBO FAILED?

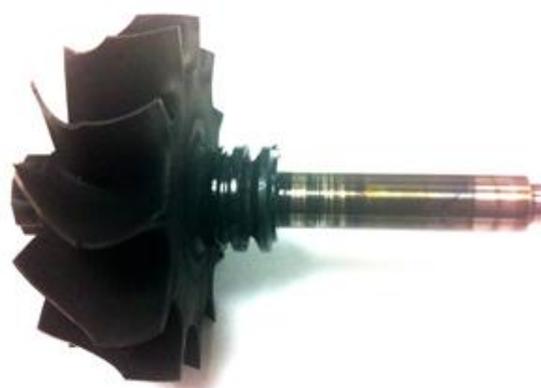
The serviceable lifespan of all oil lubricated turbochargers are dependent upon an adequate and clean oil supply. Oil flow at given pressures are controlled in the turbocharger design and in conjunction with the engine manufacturer. It is important to maintain this function as blocked oil feed pipes and/or low engine oil pressure will result in turbo failure.

Journal bearing type turbos are critical to the above as they operate on a thin film of oil under pressure, this in turn centralises the rotating mass and reduces surface friction.

Ball bearing type turbos require lower pressures and a far less volume; they are spray fed as not to over-heat the bearing. It is therefore important to ensure the correct oil feed adaptor is used.

As a guide, oil pressure to a ball bearing turbocharger should be 45psi when under load and for a journal bearing turbo, 60psi. Lower pressures are acceptable at engine idle speed.

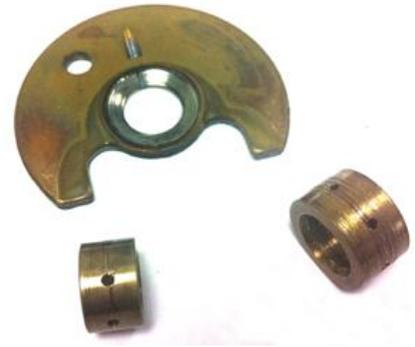
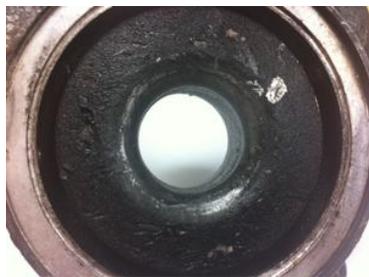
Clean filtered engine oil is a major requirement and necessity for all turbochargers. Contamination by carbon particles, dirt ingress, silicone gasket sealer and high fuel dilution will cause rapid wear to bearings, thrust faces and seals.

It is important therefore, to change the engine oil exactly to the manufacturer's specification and is also essential when replacing a turbo after a failure. The effect of worn bearings and seals can be identified by the vehicle smoking, making metallic noises and general lack of performance.

When replacing a turbocharger, **always** flush oil feed pipes and the oil drain pipe, preferably fit new, if the pipes have had blockages.

**Always replace the engine oil filter and fill with new oil.**

Should a major failure of the turbo have occurred, remove the engine sump pan and clean to collect any turbo debris that may have found its way down the turbo oil drain pipe.

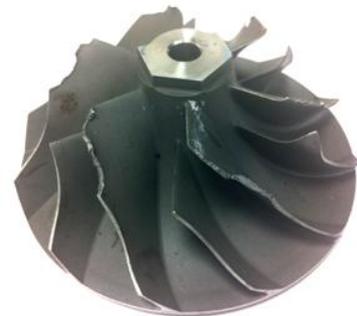
Most compressor wheel failures are visible through the air intake hose. Damaged blades and worn and bent blade tips are signs of foreign particles entering the compressor. Pitted blade edges indicate fine particle damage due to poor air filtration. In cases where all the blades are missing, foreign objects such as screws and washers may have accidentally been allowed to be drawn into the compressor housing, particularly after vehicle servicing. These parts must be found, as they can enter the inlet system of the engine. Further damage is possible to the exducer part of the compressor wheel blades and their tip heights as a direct result of over-boosting, thrust bearing wear or over-speeding. These faults can't be seen without removal of the compressor cover.

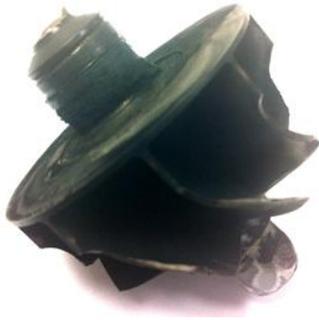
There are a number of causes where wheel failure can be experienced. The most common of these are as follows; overheating due to incorrect fuel supply giving rise to high exhaust gas temperatures, broken engine parts entering the turbine, over-speeding due to poor wastegate control, and incorrect sizing of turbine housing or restricted air supply to the compressor. Bearing seizure at high speed and the inertia contained in the rotating mass can also cause the turbine shaft to bend or shear.

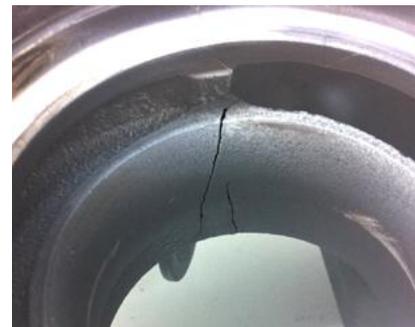
Cracks and distortion of the turbine housing are the first signs of excessive localised heat build-up. The causes are incorrect turbine housing volute size, high exhaust back pressure, and air to fuel ratio being set too weak or over fuelling causing additional combustion in the turbine. Also, too high a boost level with the incorrect ignition timing is another cause. Wastegates not opening fully can also create localised overheating.
